Cam Gear Boogie - 2002 Dodge Stratus 2.7 Vin R

Bob Powell - Bob Powell's Auto Repair

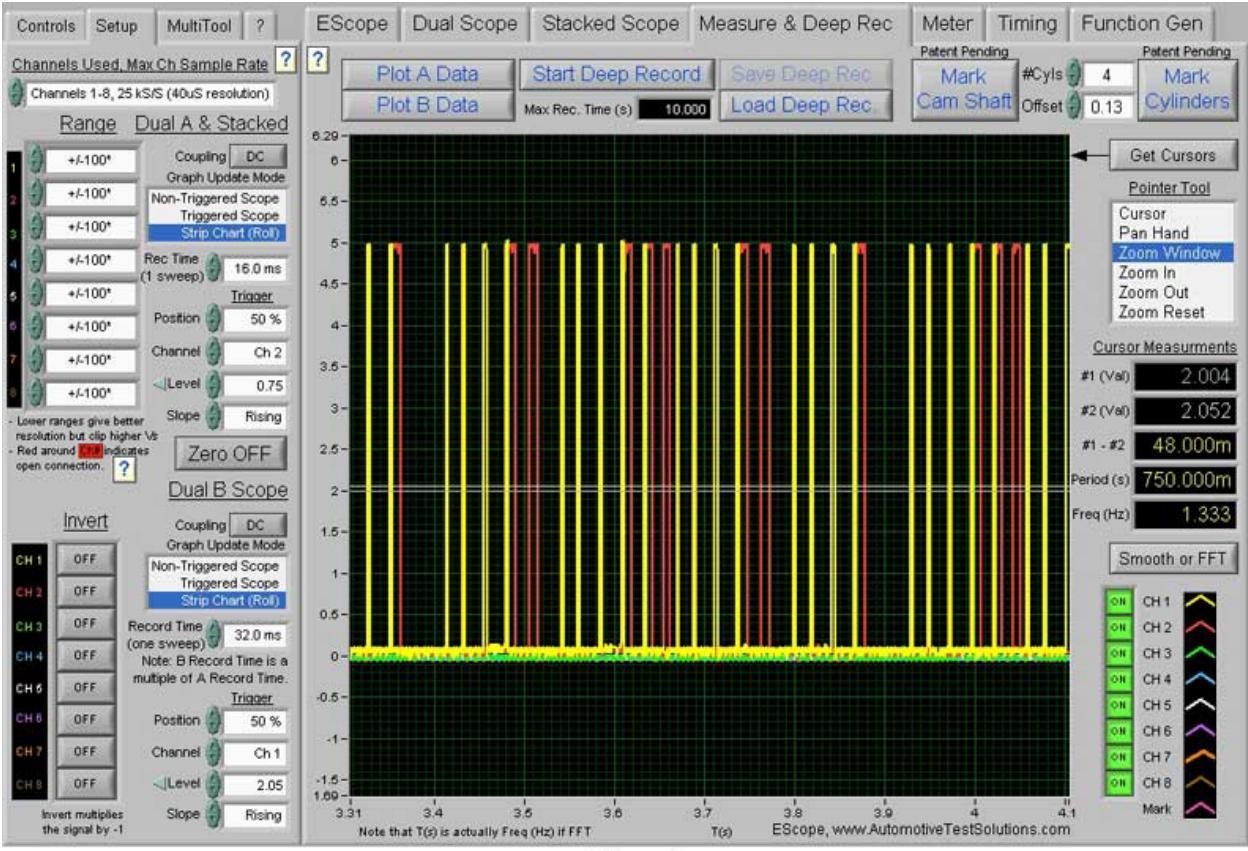
The first thing I wanted to do was see if the cam and crank sensors were in sync. I was able to start the car with the sensor unplugged, then plug it back in and get some signals. Here is what I saw (Figure 1) Note the cam waveform pattern is 1-2-3-2-1-3 which will be important information. I could not find any known good patterns that matched my cam and crank signatures so at this point the jury was still out.

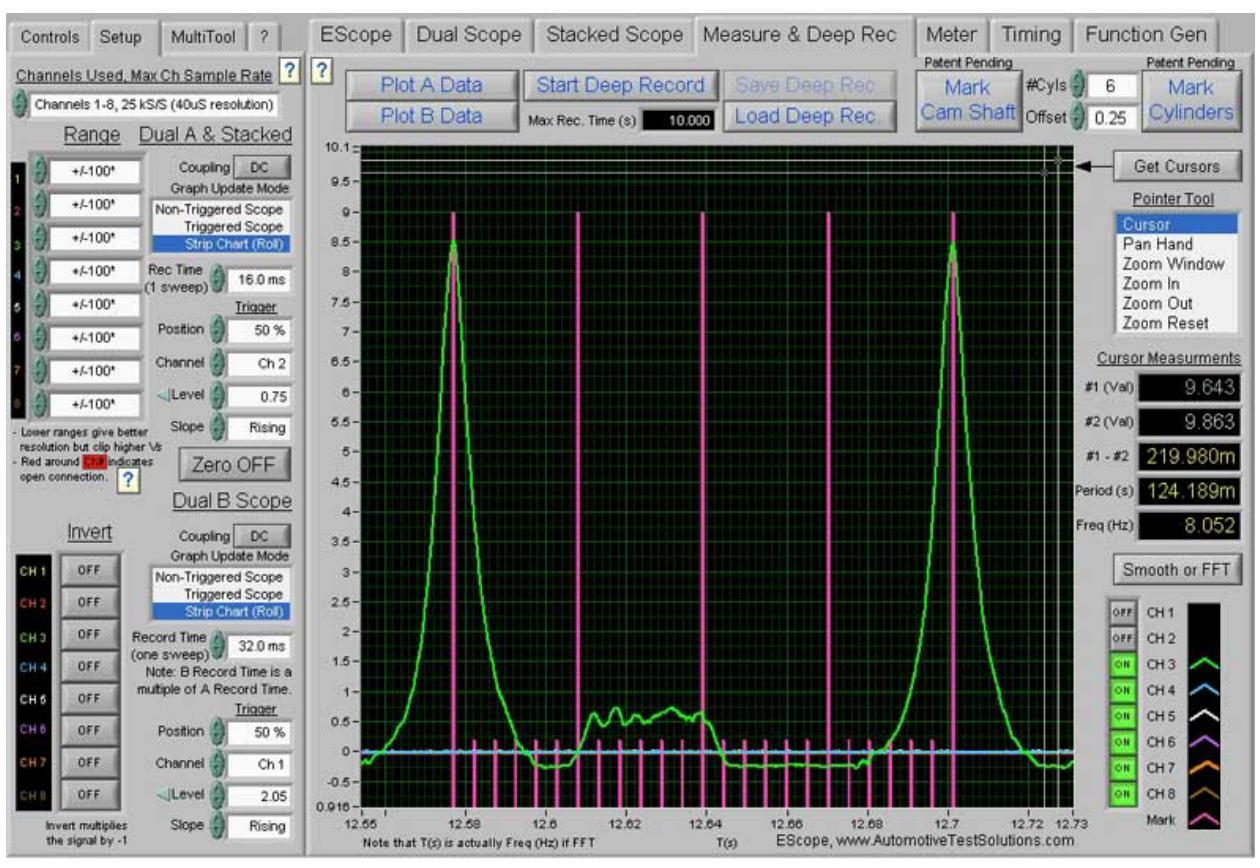
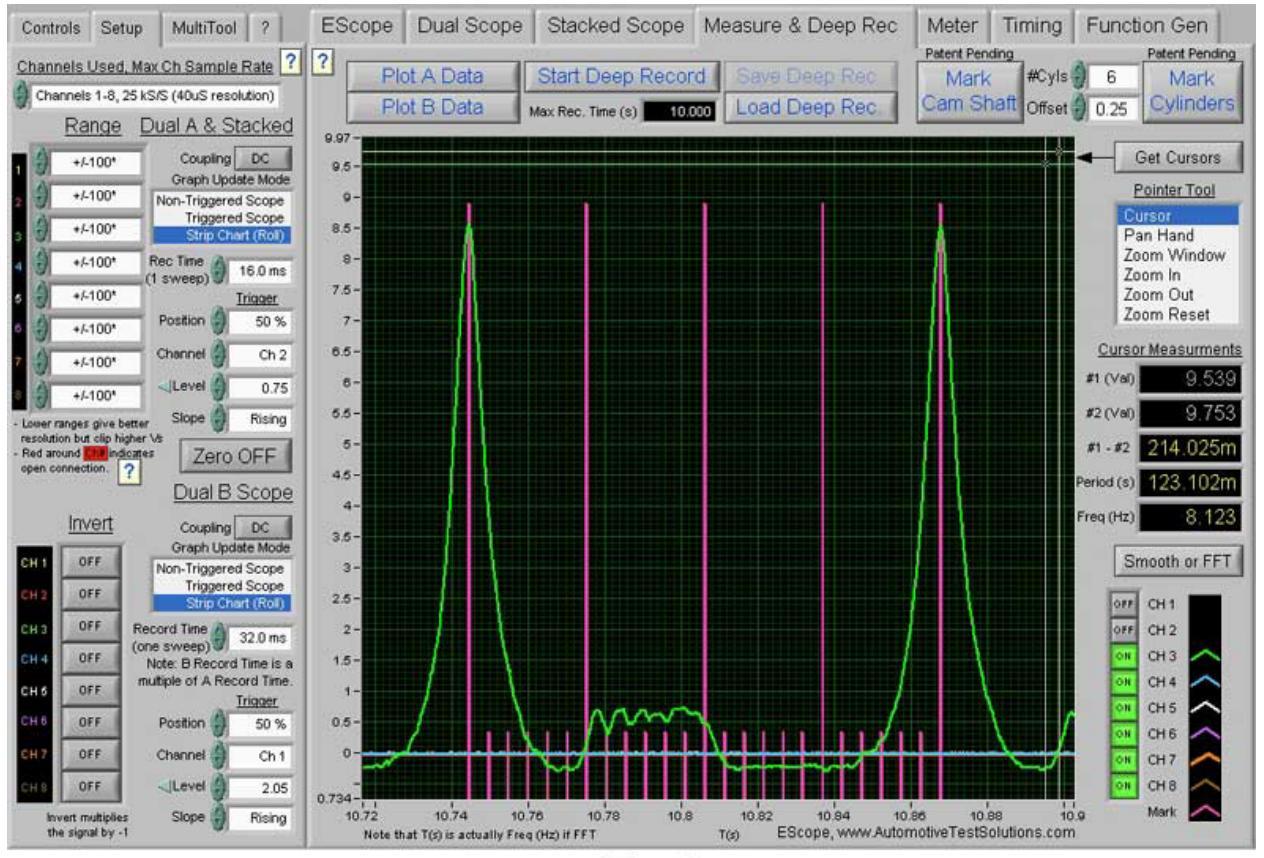
Fig. 2

Next I decided to hook up a pressure transducer in one spark plug hole on each bank to verify whether or not the cams were physically in sync. The patterns indicated that things were in proper sync mechanically. (Figures 2 & 3)

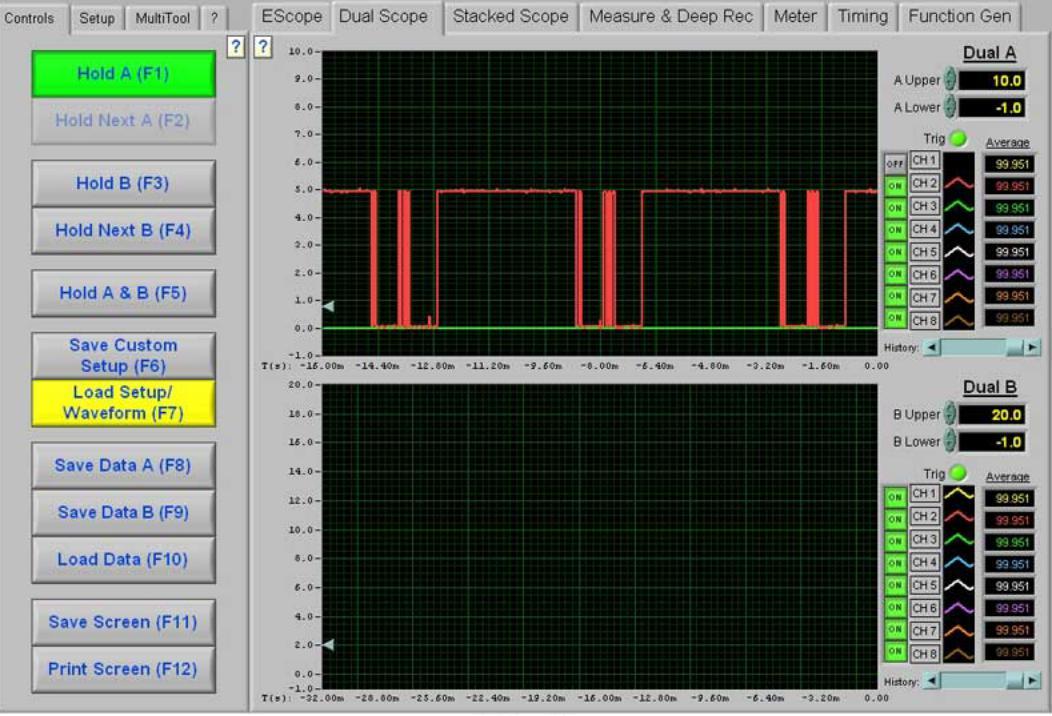
Fig. 4

One week later he comes back and says, "I replaced the gear but I have the SAME problem". I can't believe it so I hook up my scope again to see what's what. Here is what I see from the cam sensor now. (Figure 4) Big chunks of the signal are totally missing. Time to quiz the tech again. After some discussion and checking, the "new" problem was discovered. I found if I took the cam sensor hold down bolt out and tilted the sensor toward the reluctor ring, the car would start and the cam signature was correct.
